Highbridge, Stockdalewath and Gaitsgill

Flood Investigation Report No. CC9

Flood Event 22/23 May 2024

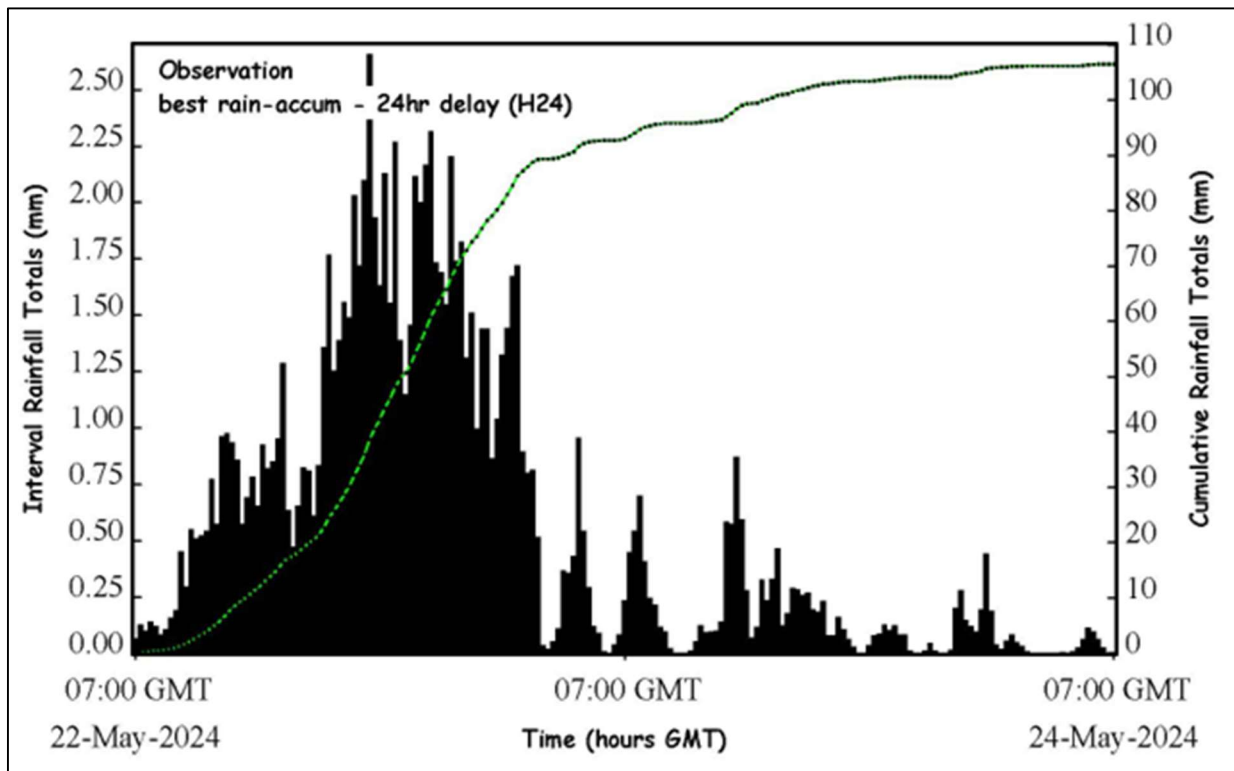
Figure 5: Catchment-averaged rainfall for the Roe Beck catchment upstream of Stockdalewath

average rainfall across the whole catchment. This data indicates that 94mm of rain fell across the catchment upstream of Stockdalewath in 24 hours (from 08:00 GMT on 22/05/2024). These rainfall totals are significant and extremely large for catchment average rainfall. However, estimating return periods for radar rainfall totals is problematic. We consider it reasonable to suggest that the event rarity for the catchment average rainfall was in the order of 1.33% to 1% AEP. Figure 5 plots catchment average rainfall accumulations at 15 min intervals and cumulative totals over 48 hours.

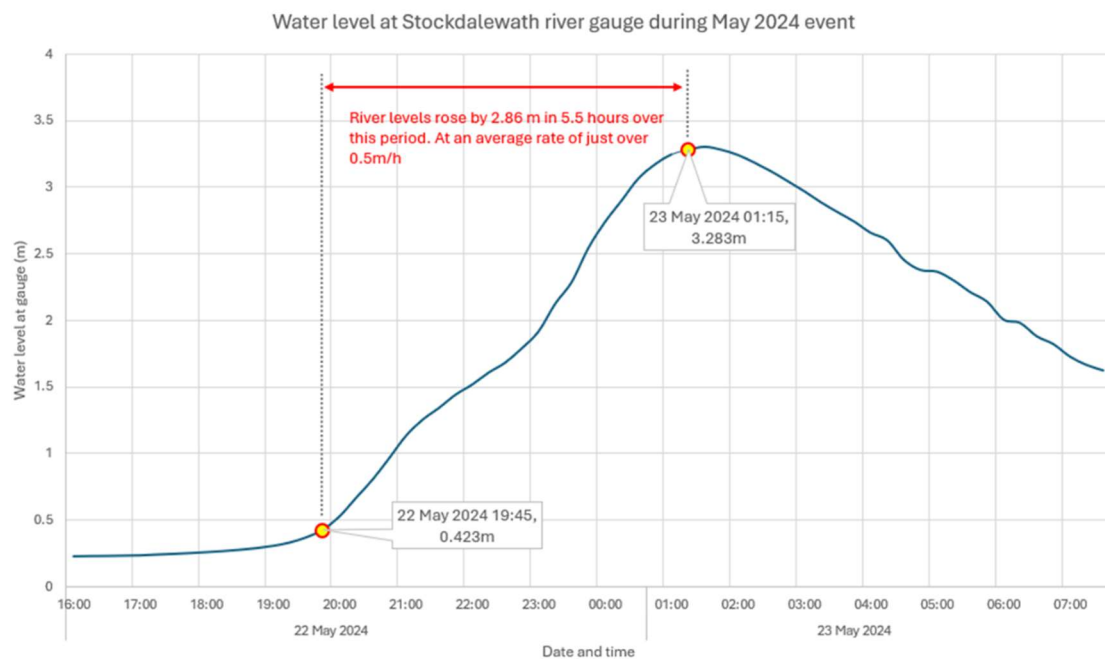
Figure 7: Average rate of rise at the Stockdalewath river gauge.

One of the most challenging aspects of the flooding during the 22nd and 23rd May was the speed at which flood waters rose giving residents very little opportunity to take action to protect themselves and their property. Figure 7 shows that, at the river gauge in Stockdalewath, river levels took a little over 6 hours to rise approximately 3m to their peak; rising at an average rate of approximately 0.5m per hour. Figure 8 compares the river levels recorded at Stockdalewath during this event with those from the three other largest events on record (January 2005, May 2013 and December 2015). The events have been overlaid so that water levels in the river begin to rise at approximately the same time but the event durations and recorded levels have not been adjusted. It is notable how similar the rate of rise and overall profile of the May 2024 event and May 2013 events are; both of which were the results of relatively localised intense rainfall.

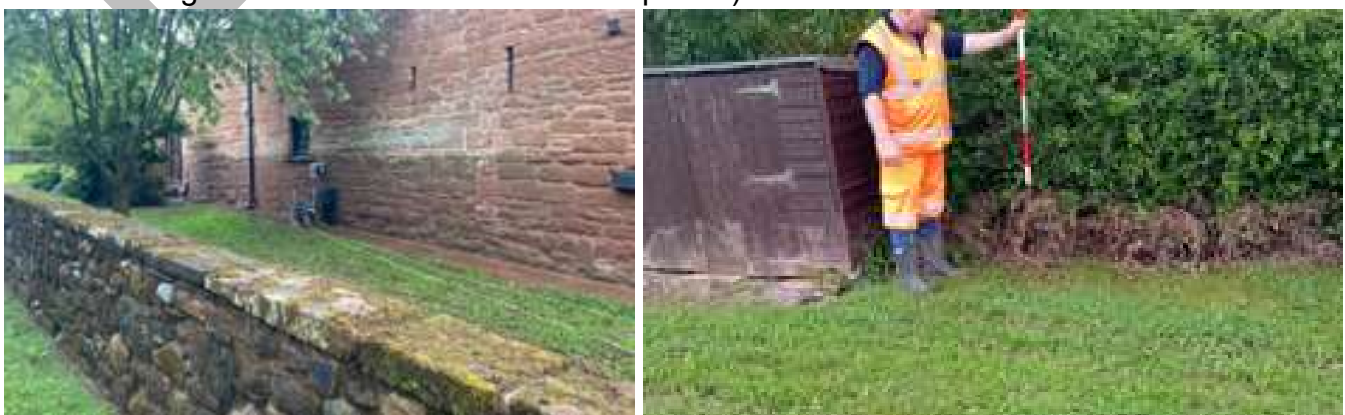
Figure 13: Wrack/water marks on property (left), EA checking flood extent levels (right)

Properties were reported flooded all around Thistlewood courtyard, but the height of the wrack/water marks on properties nearest the Roe Beck suggests some of this may have been surface water related (i.e. those nearer the top of the courtyard may have flooded from surface water running off the fields behind the development).

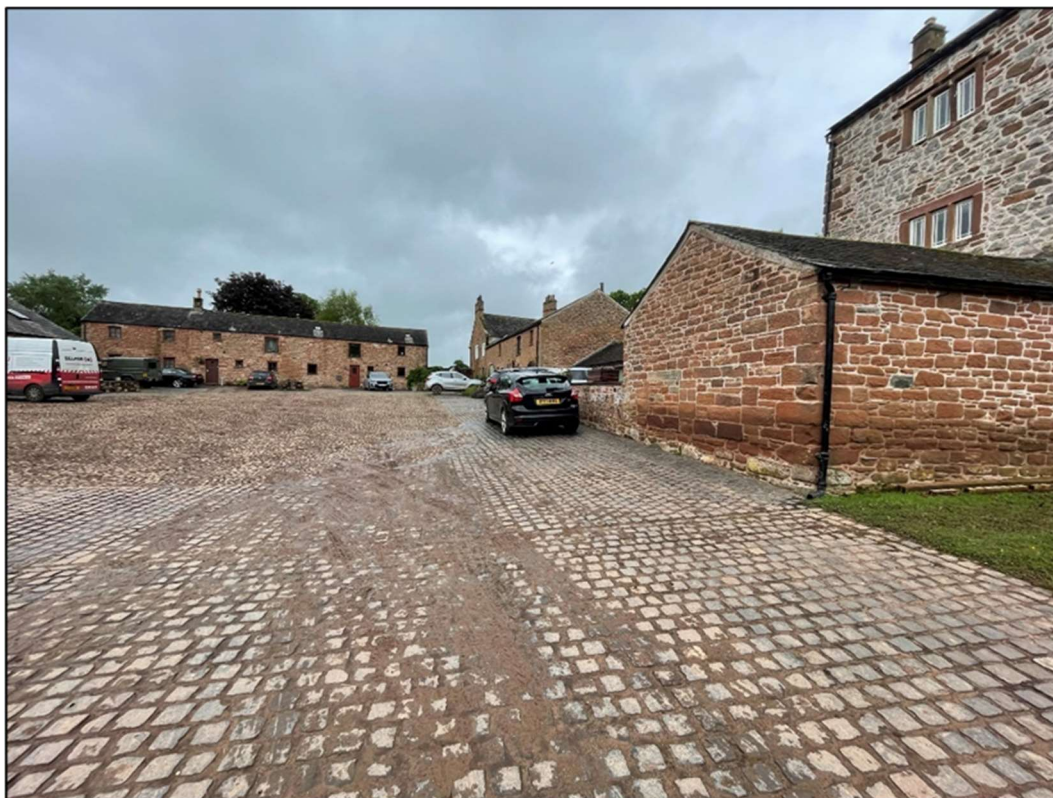
Figure 14: Water level shaded, at Thistlewood. Photo taken 27/05/2024

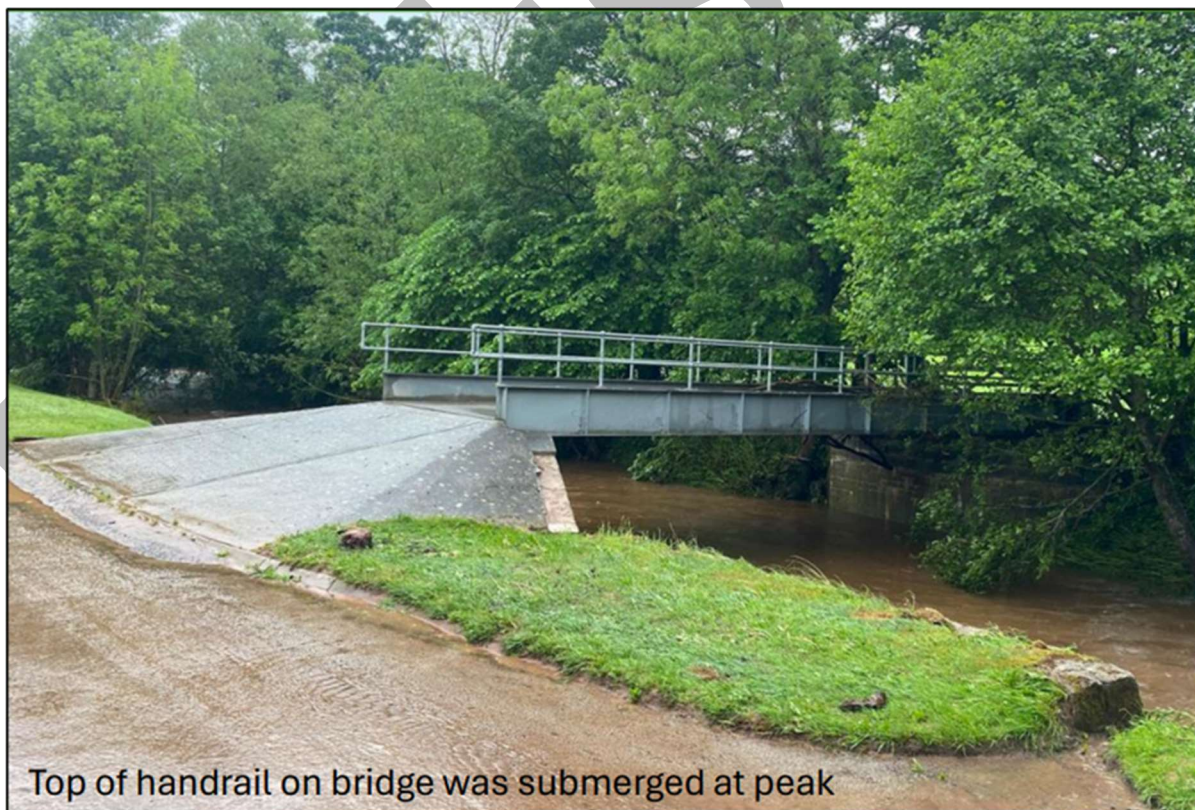
Top of handrail on bridge was submerged at peak

Figure 15: Farm access bridge. This access bridge was raised after the flood event in 2013 but the river was above the top railing in the May 24 flood.

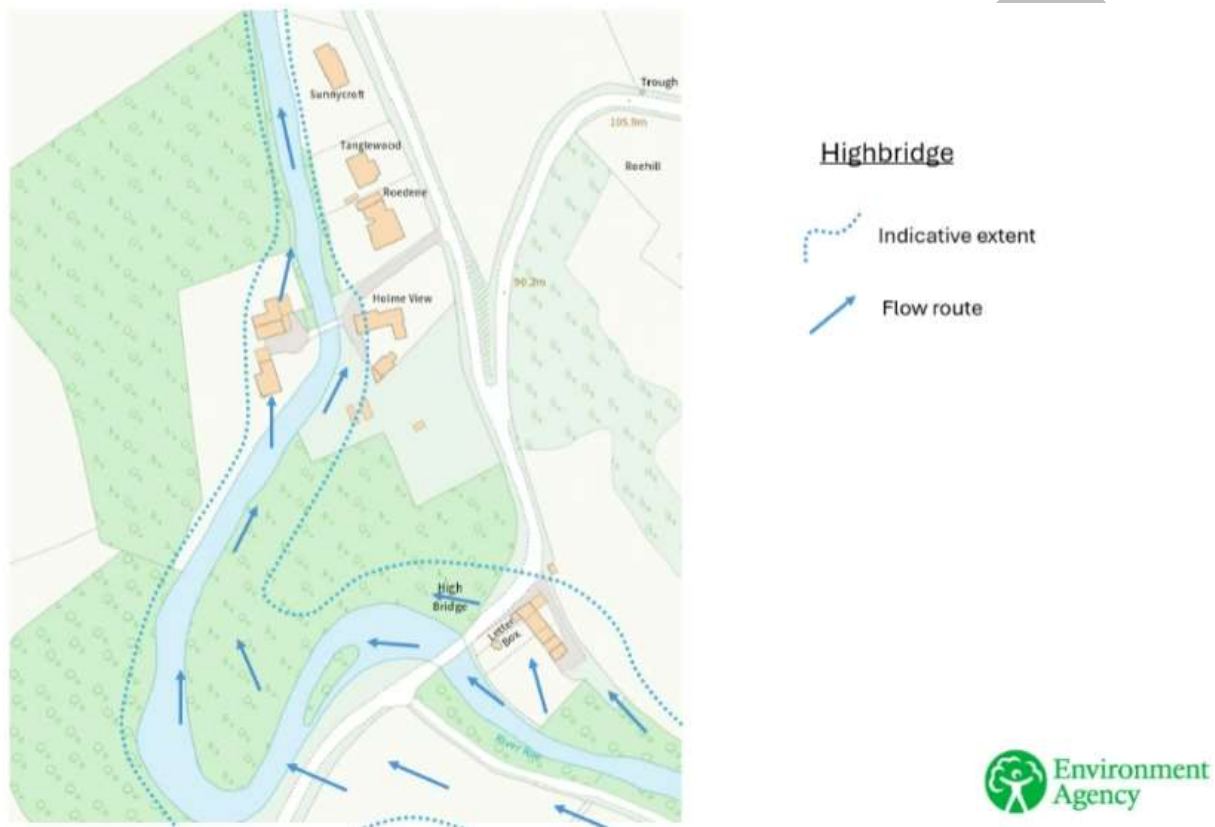
Figure 16: Flow routes at Highbridge

Highbridge is a collection of properties that lie predominantly on the right-hand side of the Roe Beck, downstream of the road junction to Thistlewood at High Bridge. Highbridge House sits on the left-hand side of the channel and is accessed via a narrow vehicle access bridge. Numerous cottages were flooded by the river, above a depth of one foot (up to 2 feet in parts of the property nearest the river). Initial flooding was via a surface water flow route that inundates the highway gully. A resident reported the levels were beyond those seen in living memory, and that the house had not flooded before. A property further downstream was also flooded. Flood water left the river channel and surrounded the property. The access bridge was inundated.

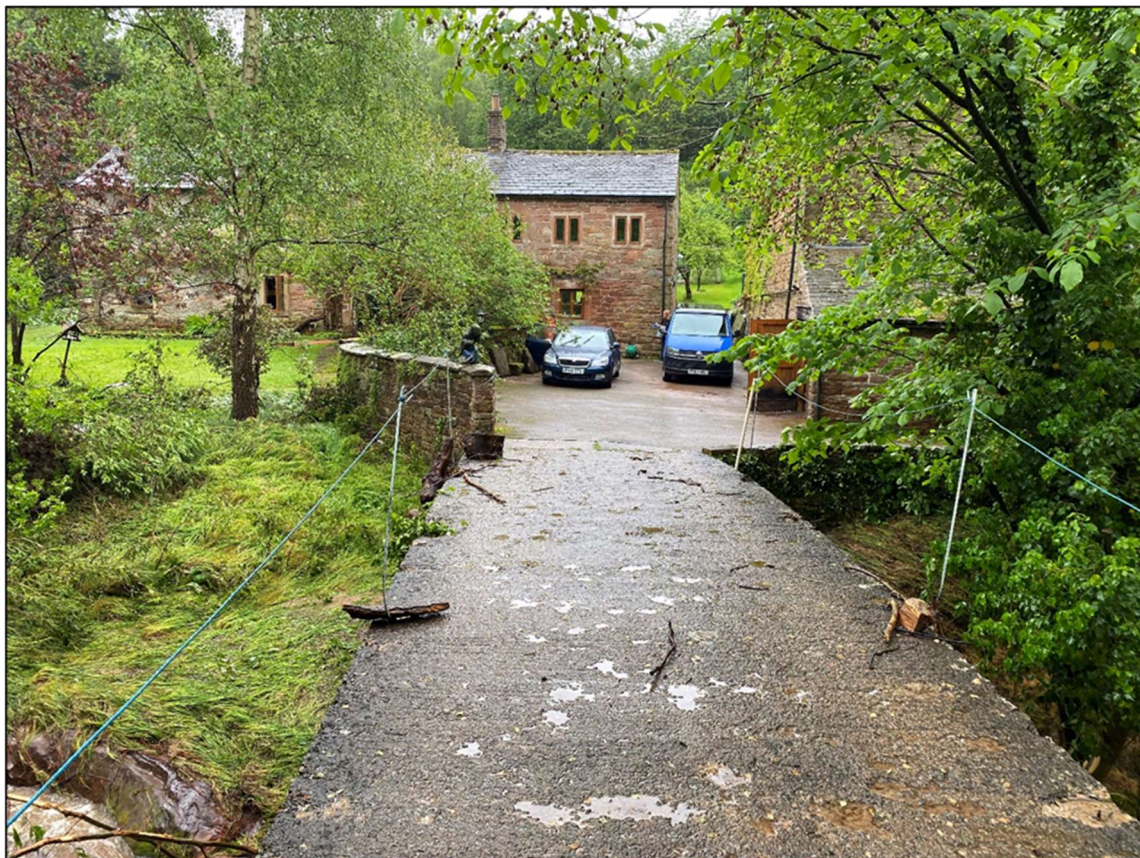
Figure 17: Bridge across Roe Beck. River flowed over the top of this bridge

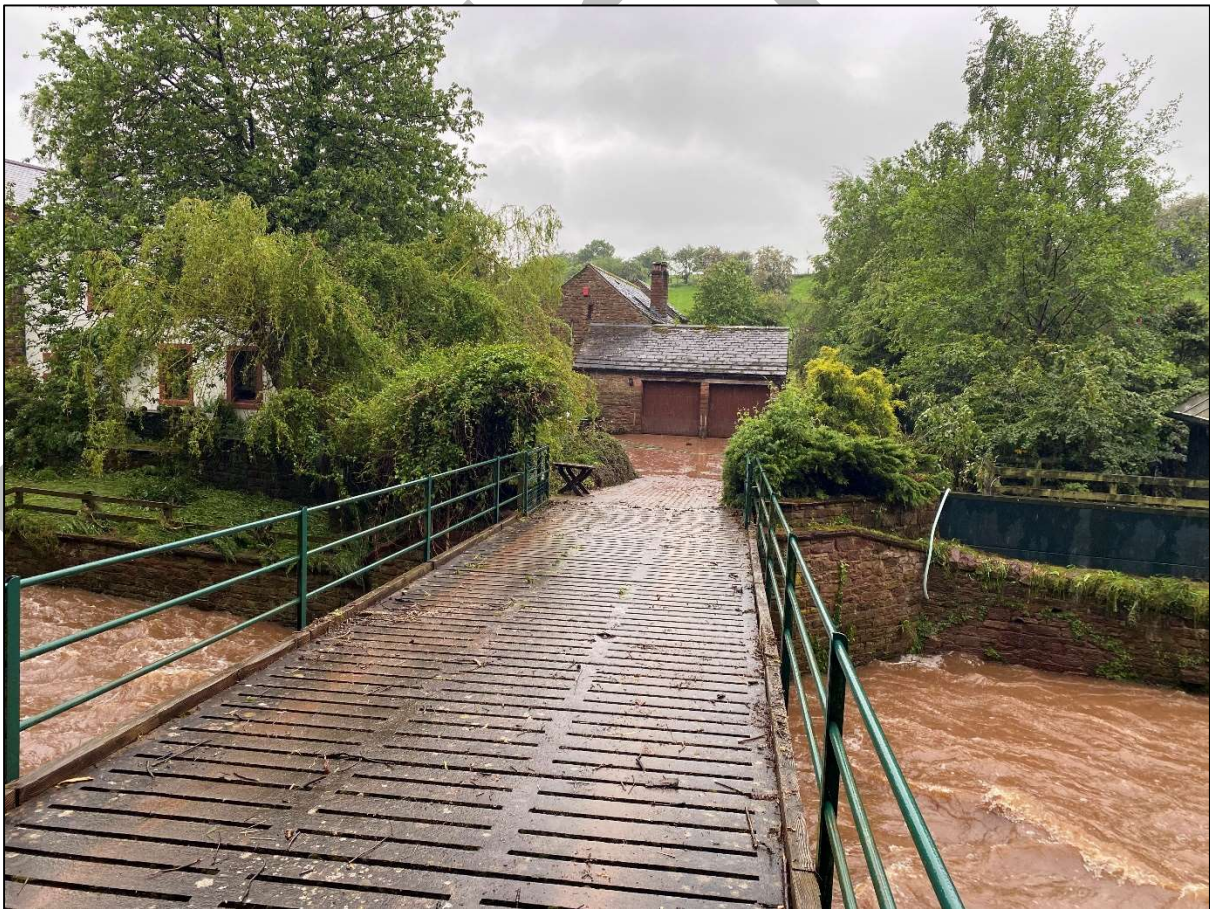
Figure 19: Access bridge to Hempgill. Flood level was above bridge deck.

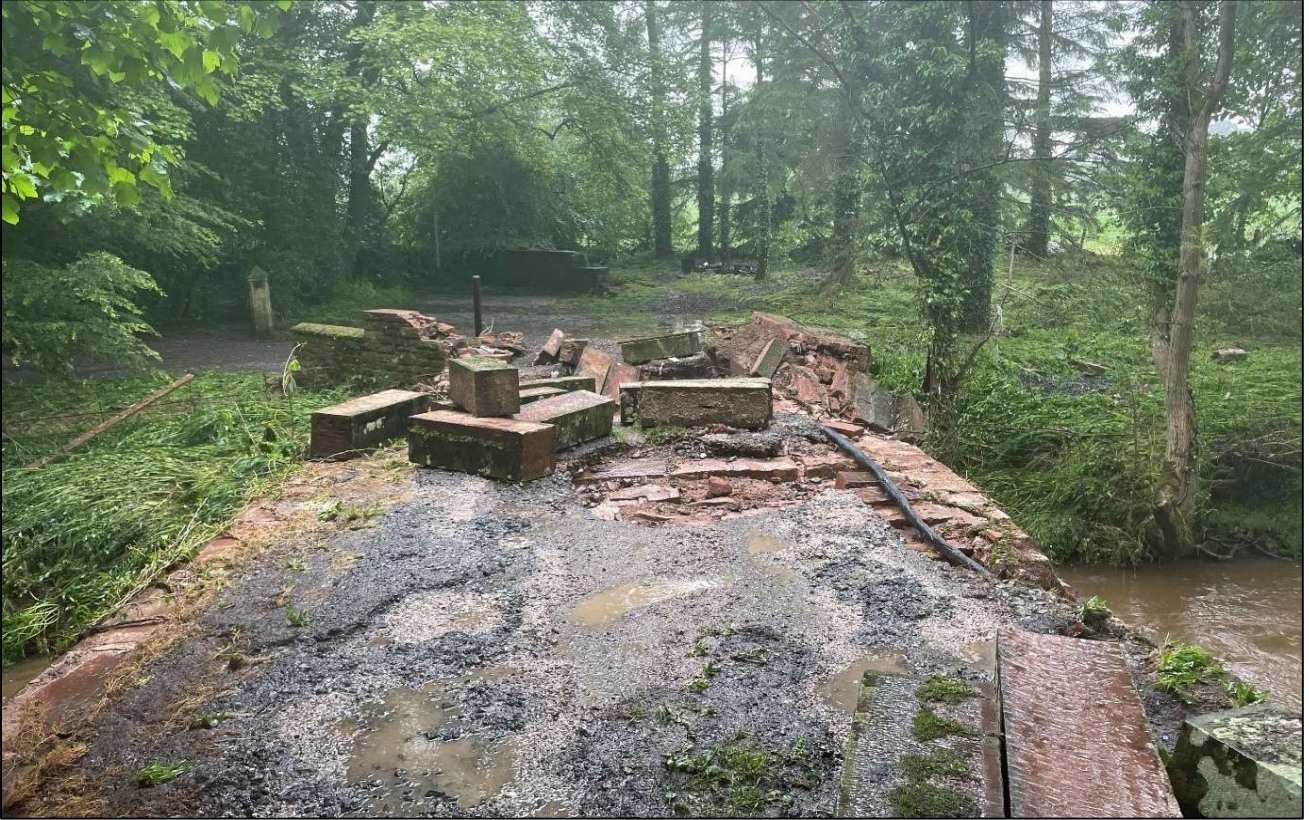
Figure 21: Partially collapsed access bridge at Roewath. Photo taken on 24/05/2024.

Most of the affected properties are located on the west side of the Roe Beck and accessed by private access bridges. Both of these bridges were overtopped during the event meaning that residents were trapped in their properties. One of the private access bridges partially collapsed, Figure 21.

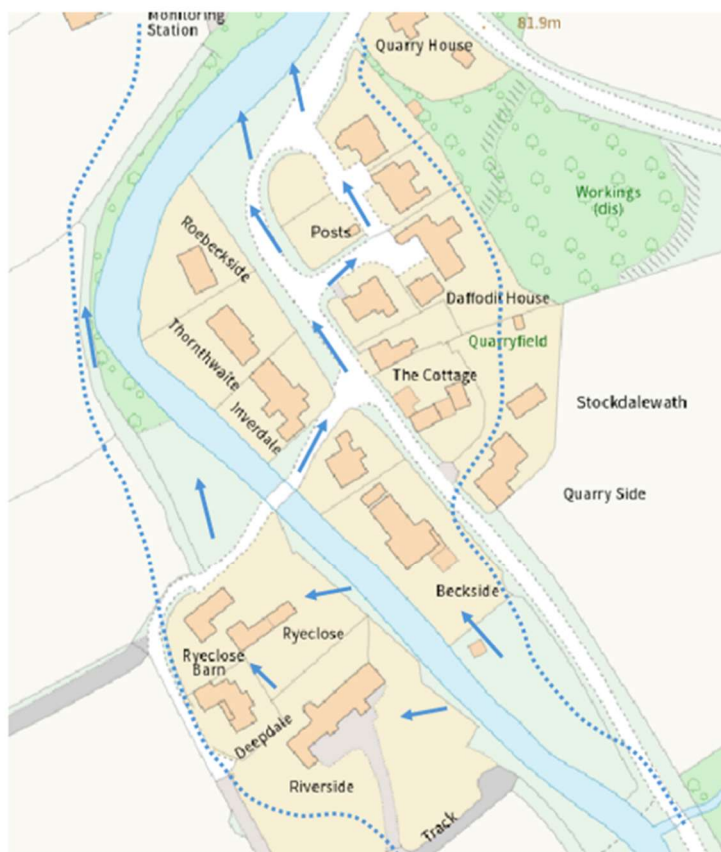
Figure 22: Flow routes upstream of main road bridge, Stockdalewath

Upstream of the main road bridge in Stockdalewath there was severe flooding affecting properties and highways on both sides of the river. It is understood that as many as 12 properties in this area suffered internal flooding with further properties suffering external flooding as well as flooding of outbuildings and garages.

Flooding in this area was from Roe Beck which exceeded the capacity of the river channel and of the small access bridge which forms the sole access route for 5 properties on the west side of the river. Once the deck of the bridge had been overtopped there was no safe access or egress route for the residents of these properties until the floodwater had subsided. It is understood that the railings on the bridge had previously been removed in order to minimise its impact on upstream water levels. The bridge now has a relatively low profile and will have been unlikely to have had a significant influence on peak water levels.

The first properties known to have flooded in this area, on the western side (left hand bank) of the river, were inundated at approximately 12:30am as water came over a private flood wall constructed following the 2005 event.

As water levels in the river continued to rise flood water started to flow up the road on the eastern side of the bridge until it reached the road to Highbridge where it flowed north-west along both this road and Quarryfield.

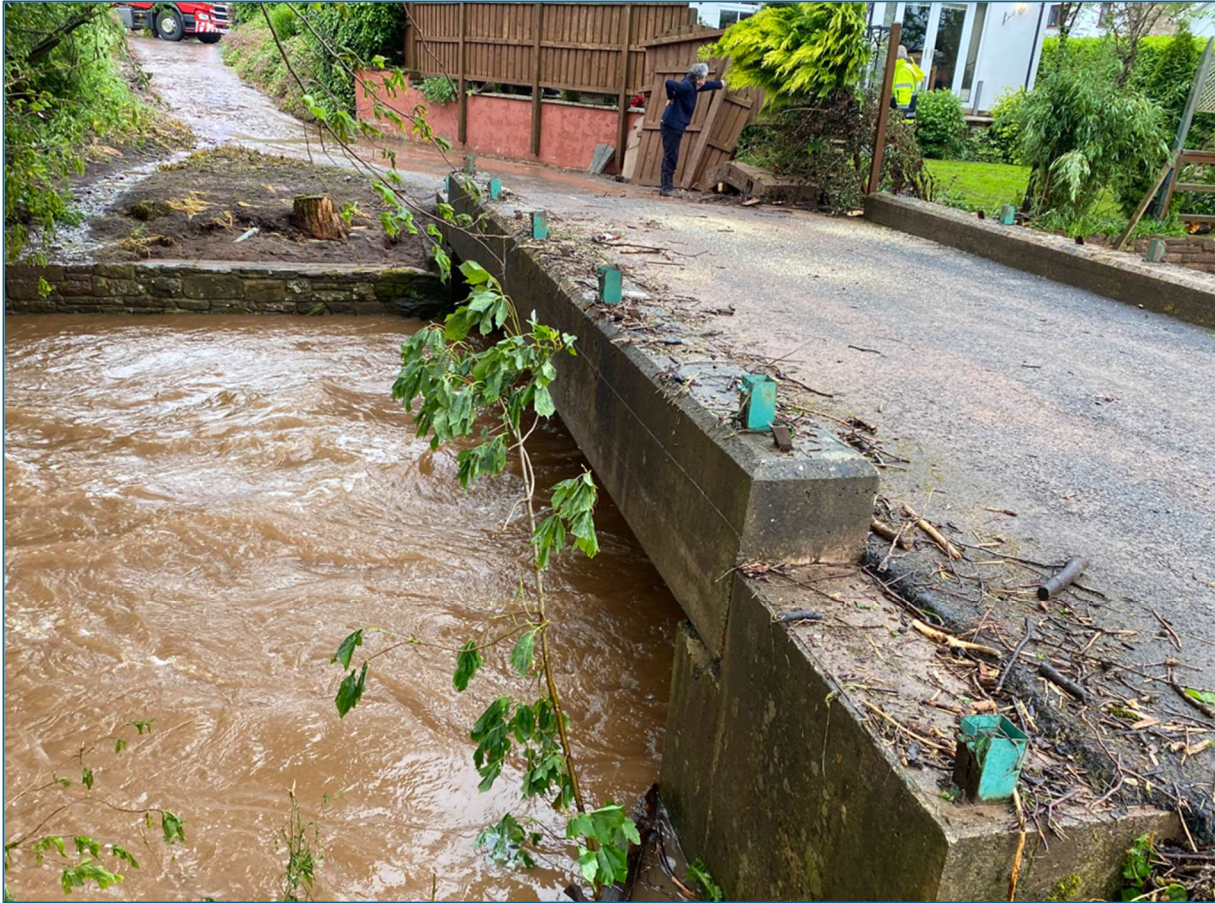
Figure 23: Small road bridge in Stockdalewath. Photo taken 23/05/2024

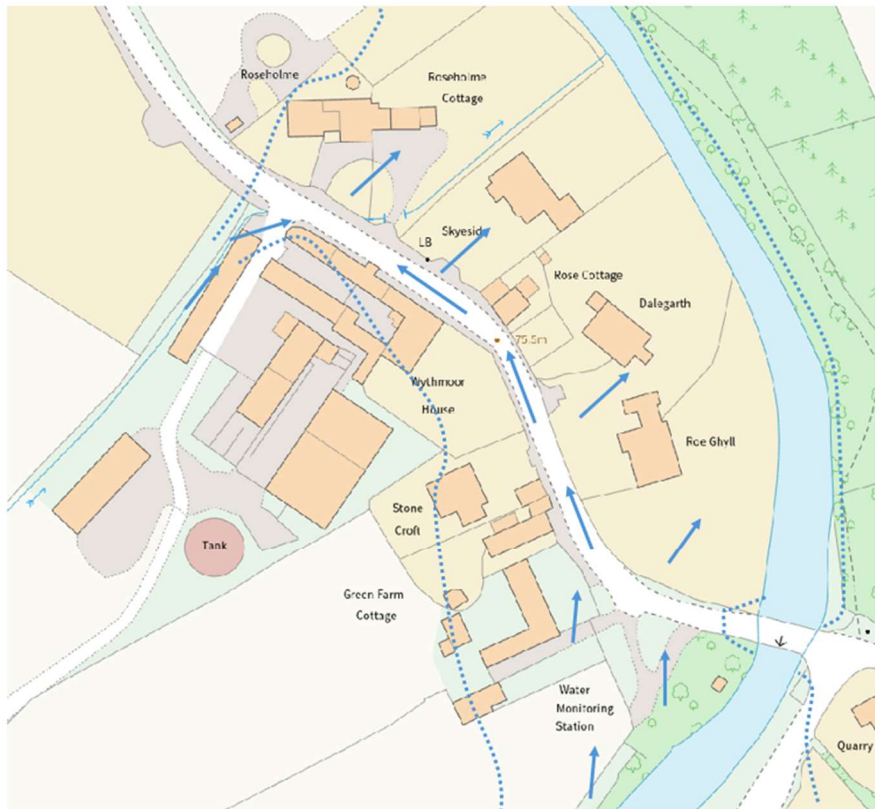
Figure 24: Flow routes downstream of the main road bridge, Stockdalewath

Downstream of the main road bridge in Stockdalewath there was severe flooding which caused extensive damage due to both the depth and velocity of the floodwater. The majority of the floodwater came from Roe Beck; however, overland flow and flow from the stream entering the village from the west also contributed to the flooding.

Floodwater overtopping the left (western) bank of the Roe Beck flows onto the road past the kiosk of the Environment Agency river gauge. Some of this flow crossed the road and flows across the field opposite back towards the river. However, a significant volume of flood water was also conveyed north-west along the road and into the centre of the village leading to internal flooding of a number of homes as well as extensive damage to walls, driveways, gardens and property. The first property known to flood in this area was inundated at approximately 11:40pm on the 22nd May.

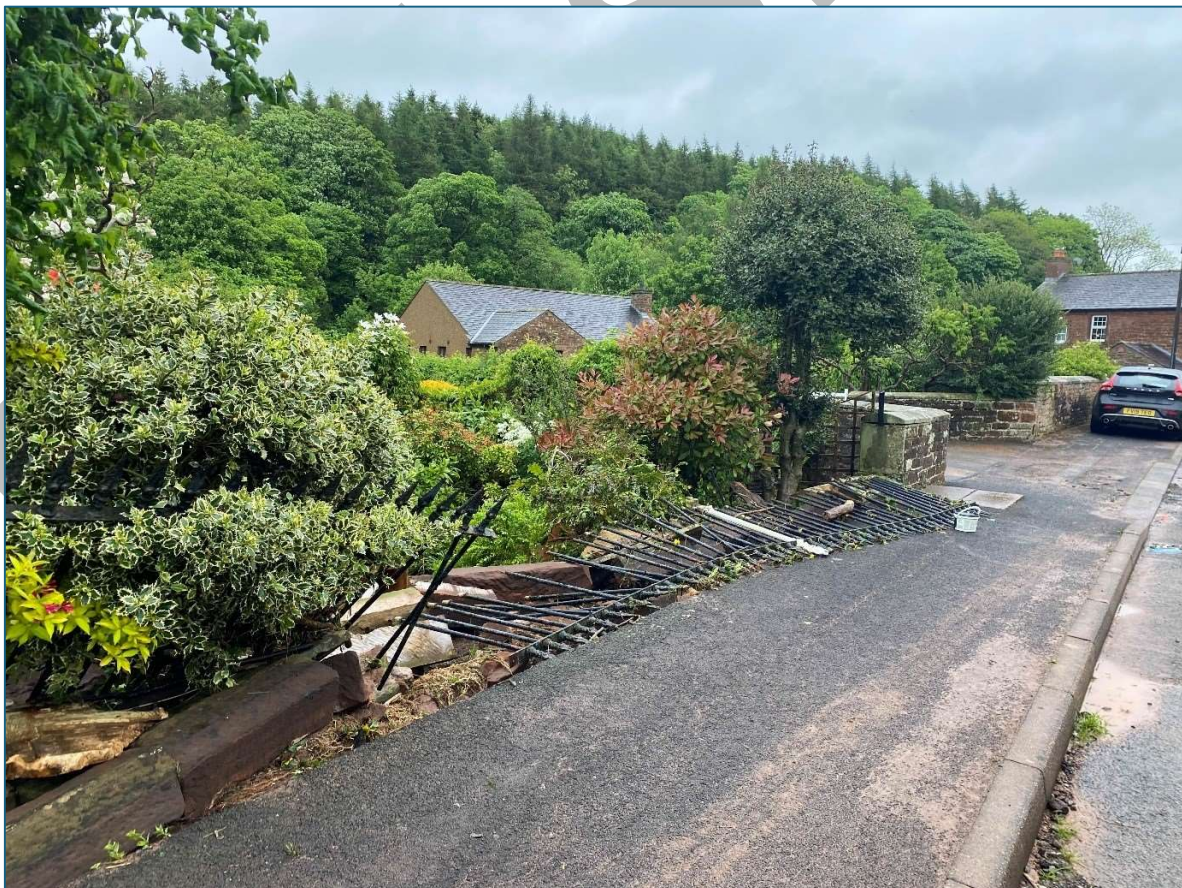
Figure 25: Boundary wall and fence at Stockdalewath pushed over by flood water

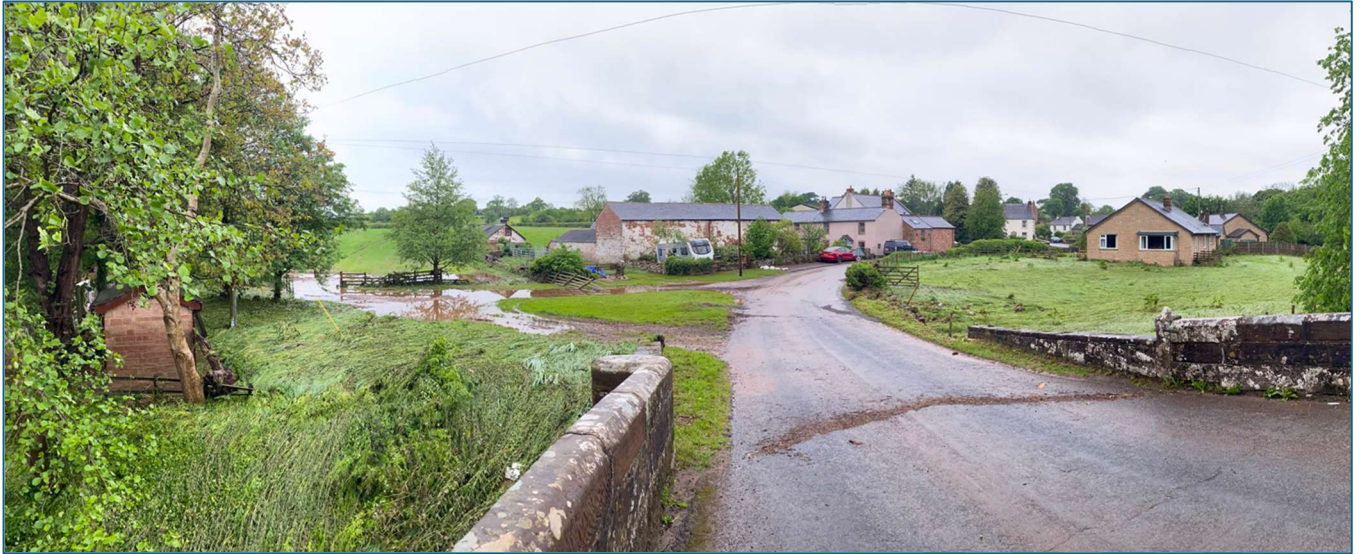
Figure 26: Looking from the main road bridge west towards Stockdalewath. High water mark on the bridge approach is visible in the foreground. Damage to field boundaries (walls and fences) on both sides of the road.

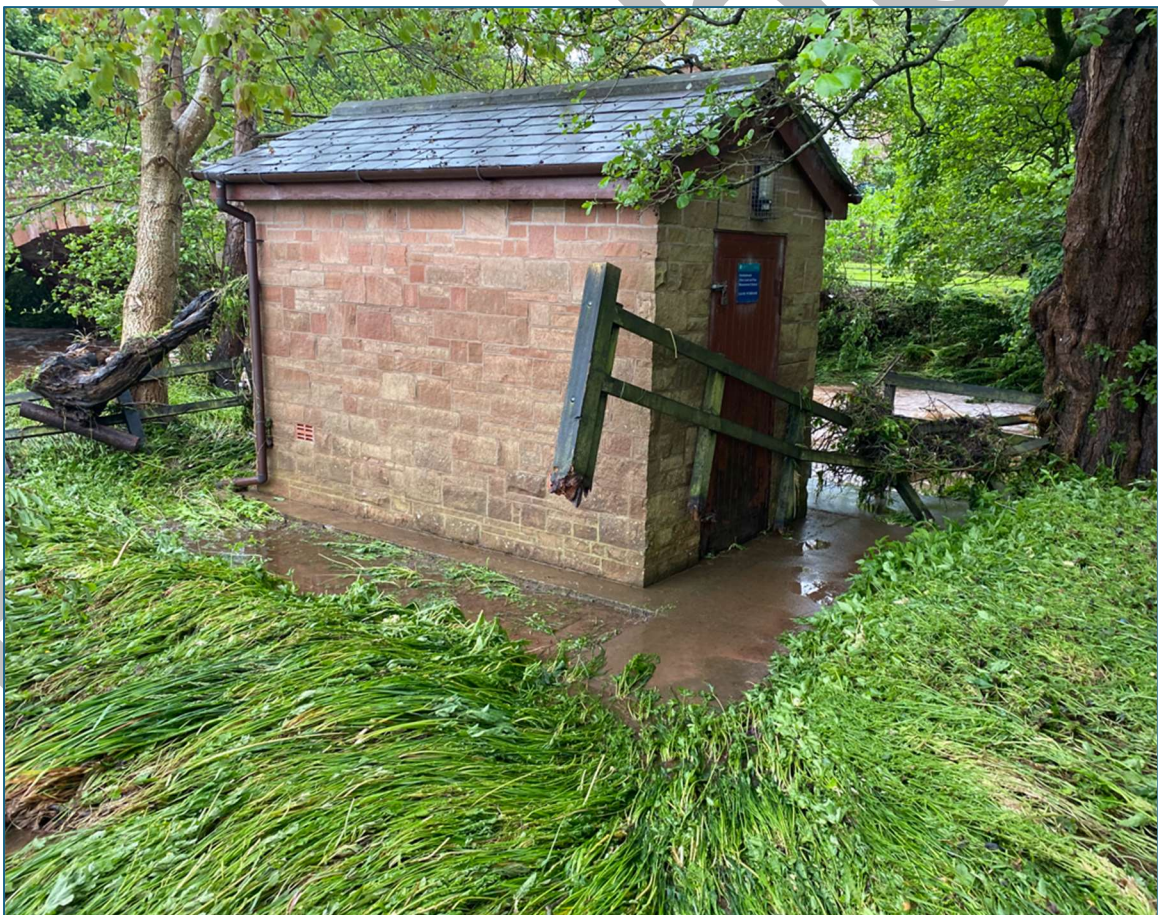
Figure 27: The kiosk of the Environment Agency river gauge. High water mark is faintly visible on the external walls, this was far clearer inside the building.

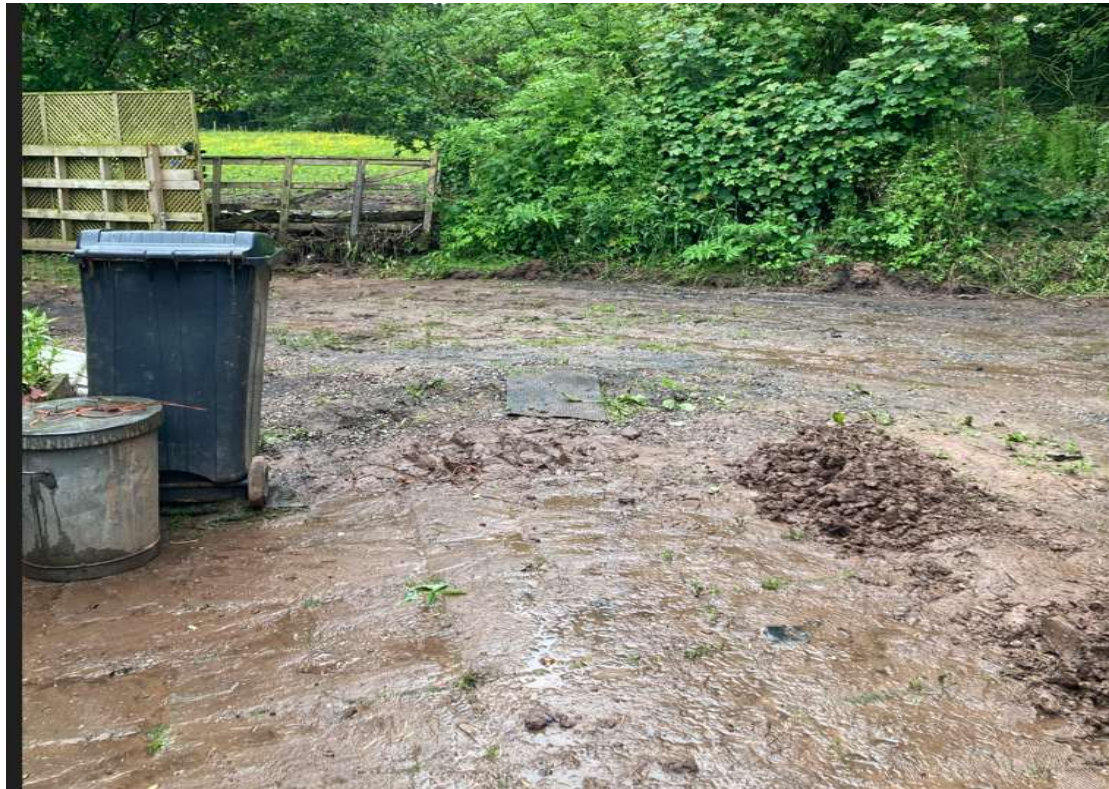
Figure 29: Field access gateway where flows exceeded from Pen Beck

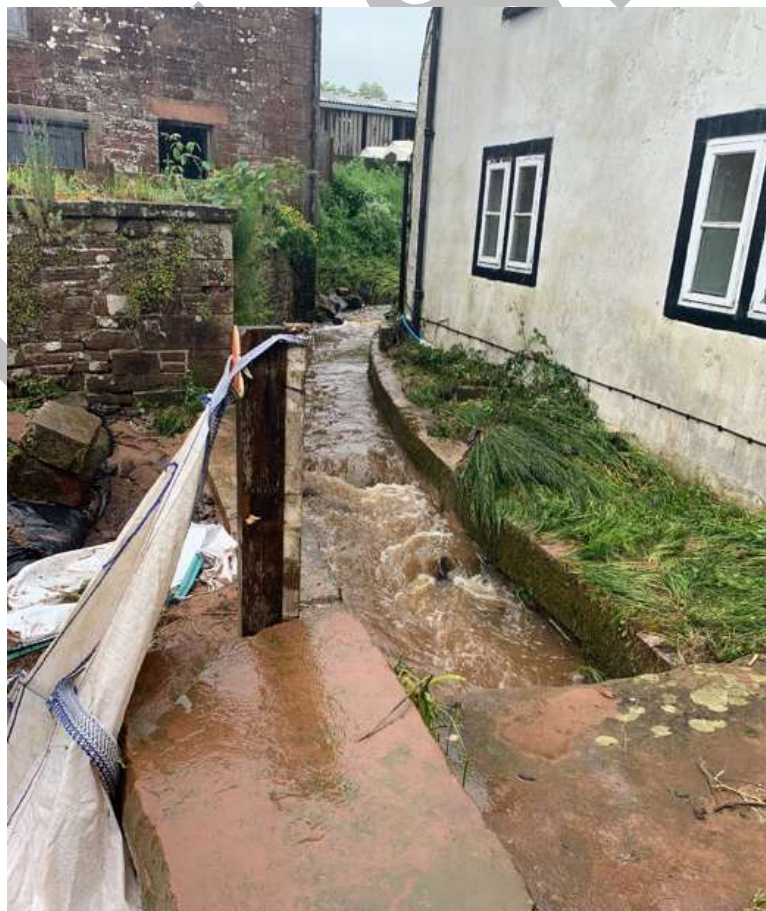
Figure 30: Pen Beck along from Chapel House on the U1143 road. Main flood exceedance point in Gaitsgill.

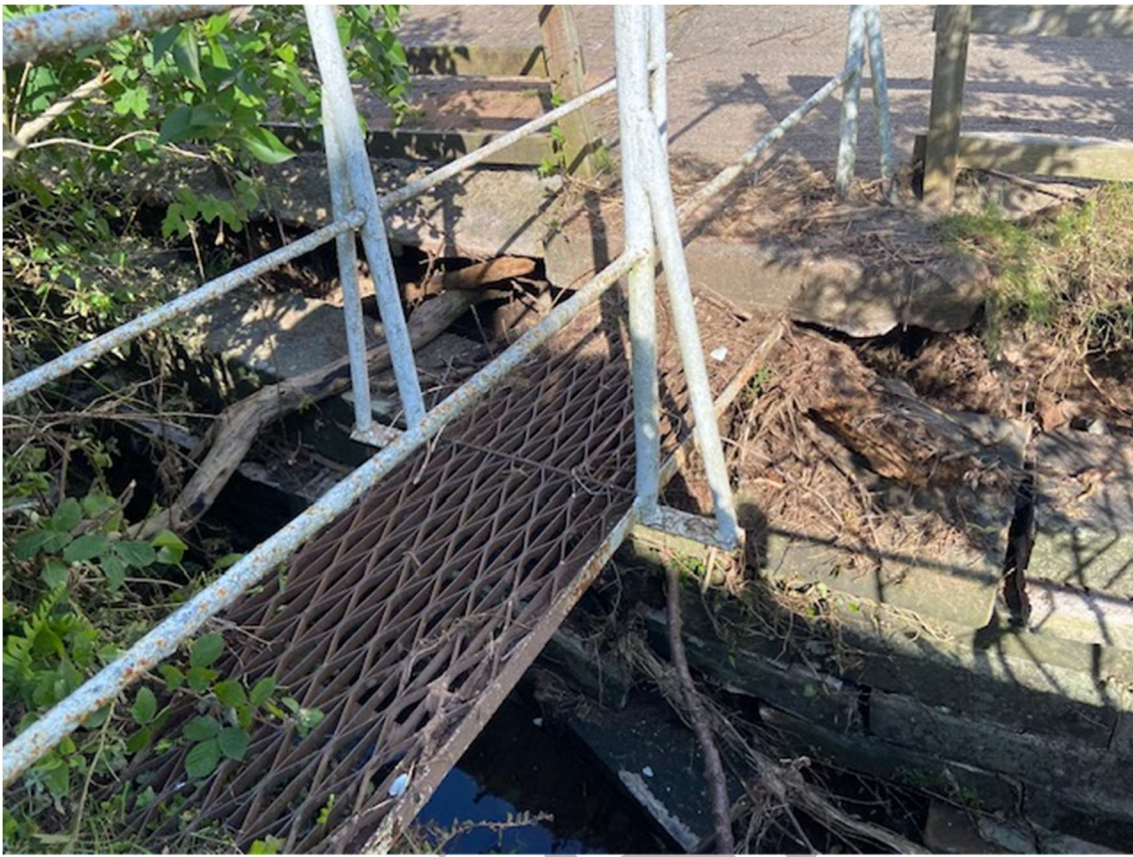
Figure 31: Footbridge accumulating debris
